S8050-20Q4C Switch Technical White Paper

After-sale Instructions for Error-prone Issues

Model: \$8050-20Q4C

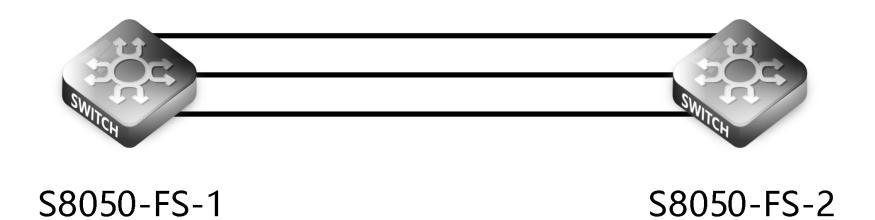
1.2 Topology Information

When the LINK AGGREGATION function of the S8050 series switches is configured, when the LINK AGGREGATION dynamic mo de is configured, the active interfaces selected by the devices at both ends are inconsistent, resulting in the inability to esta blish a link aggregation group.

In summary, when the LINK AGGREGATION dynamic function is used in the S8050 series switches, the negotiation of configuring the LINK AGGREGATION function fails because the selected active interfaces are inconsistent.

When configuring the LINK AGGREGATION dynamic function, configure the LINK AGGREGATION function according to the spec ifications. When configuring the LINK AGGREGATION dynamic function, the active interfaces selected by the devices at both e nds must be consistent, or they can be directly selected according to the LACP system priority. Active interface.

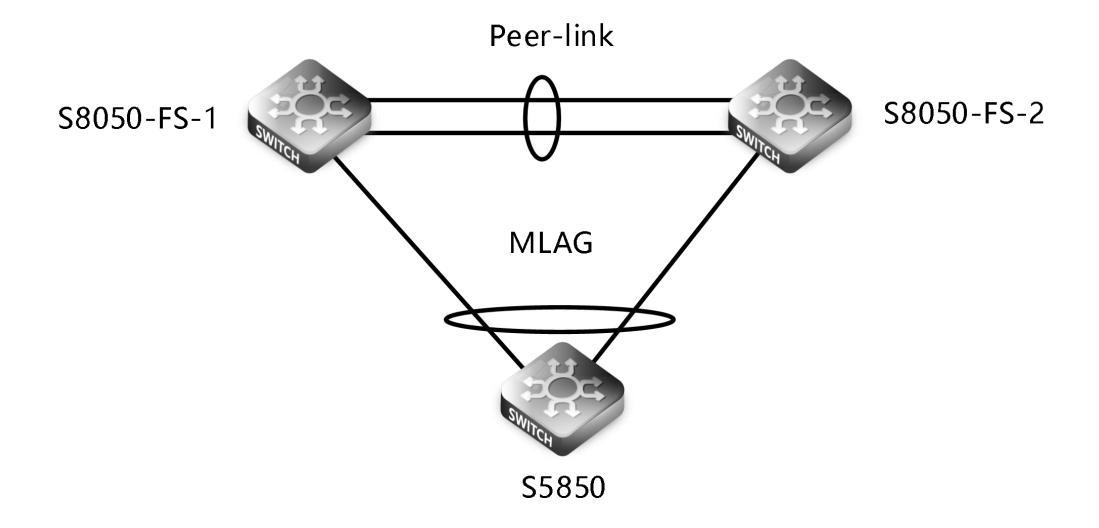
2.2 Topology Information

If the S8050 series switches enable the MLAG function when the spanning tree protocol is enabled, the MLAG function configuration will be abnormal.

Due to the characteristics of S8050 series switches, spanning tree protocol and MLAG cannot be used at the same time, oth erwise it will cause abnormal MLAG function.

When configuring the MLAG function, please disable the spanning tree protocol of the corresponding port.

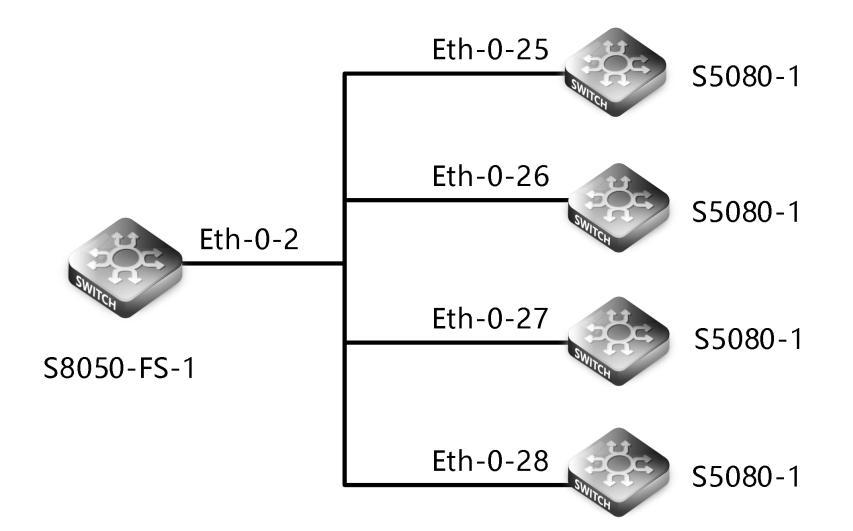
3.2 Topology information

When the S8050 series switch port is split and the four-port DAC is connected to the four ports of the S5080 series switch and aggregated, the port aggregation operation cannot be performed.

The split operation of the Eth-0-1 port of the S8050 device is the first four 10G ports of the device, and the S5080 switch port connected to the S8050 switch is a layer 2 port, which will cause loop problems.

On the S8050 switch, change the Eth-0-2 port and the peer switch for port aggregation, or change the cable to operate the first four 10G ports of the S8050 switch and the peer switch, and modify the Layer 2 port of the peer switch to three Laye r port will perform port aggregation, and there will be no loop at this time.

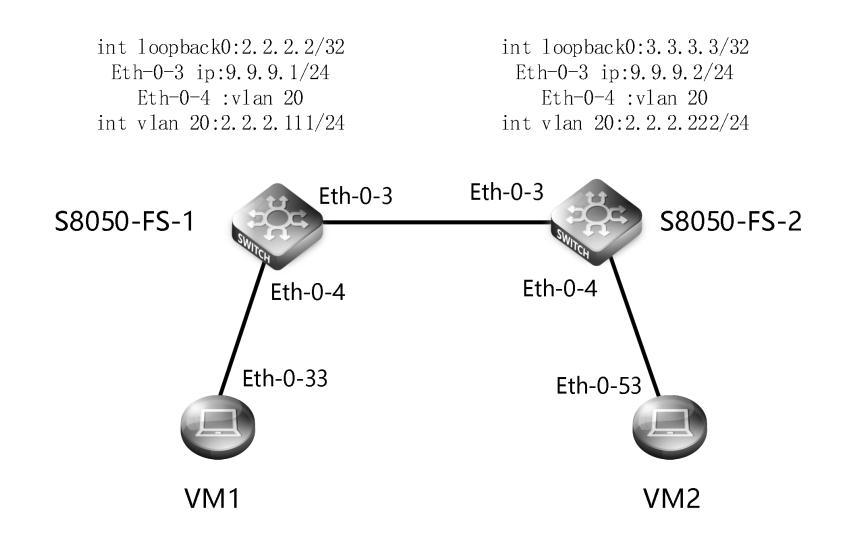
4.2 **Topology Information**

Use distributed routing to establish a VXLAN tunnel to achieve private network communication. The VXLAN tunnel is establis hed successfully but the tenants under the private network cannot communicate.

When configuring the network, if the network IP address conflicts, the underlying network cannot communicate. The VXLAN t unnel must be configured to ensure that the Underlay network must be interoperable. When configuring the Overlay networ k, errors in the endpoints of both ends of the Vxlan tunnel will cause the route to not be learned.

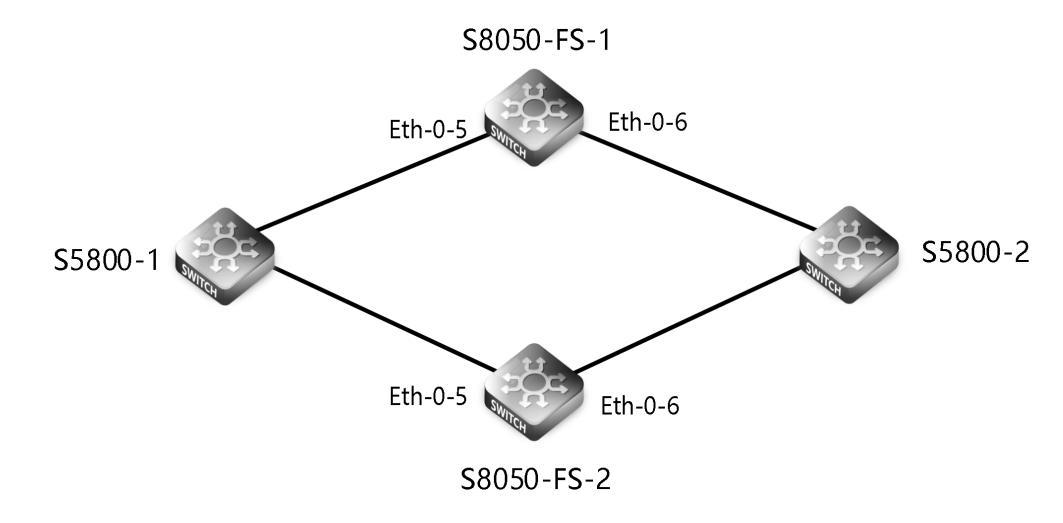
5.2 Topology Information

When VRRP technology is used to configure a redundant gateway, when the master device fails, the Backup device cannot quickly switch between the master and backup to continue to carry traffic.

In the above network, S8050-FS-1 is configured with a priority of 100 to become a master device, and S8050-FS-2 is configur ed with a priority of 90 to become a backup device. When the uplink fails, the status of the master device will be In Initiali ze state, when the link state is restored, the device will first switch back to Backup state and then wait for the preemption delay time to switch back to Master state, during which the waiting time is too long.

When the VRRP redundant gateway is configured, the failure monitoring function is not configured, and when the network fa ils, the main and standby switching cannot be performed quickly.

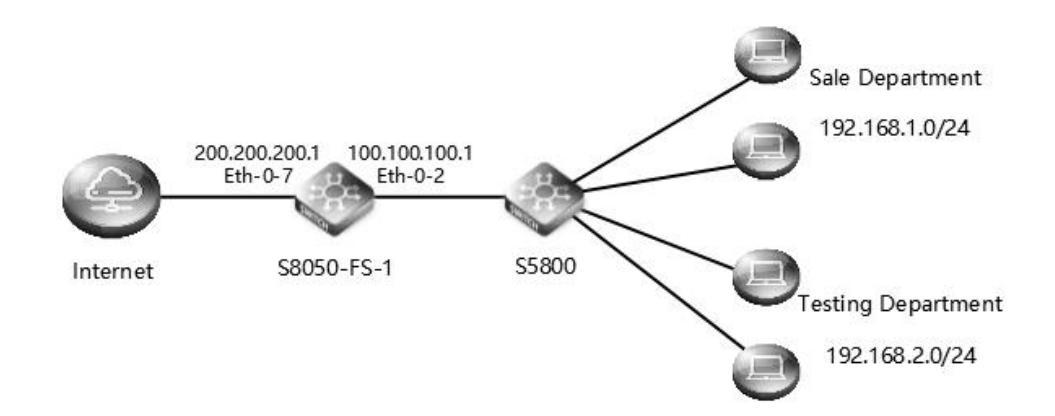
6.2 Topology Information

external network cannot access the external network.

Check whether the network can communicate with each other. Ping the IP address of the S5800 switch on the S8050 can be pinged, and the directly connected network segment can be pinged. On the S8050, ping 192.168.1.0 and the network segment 192.168.1.0 are both unable to ping.
